## **Outfall 002A – TCE Exceedance in March 2016 and Plan of Action**

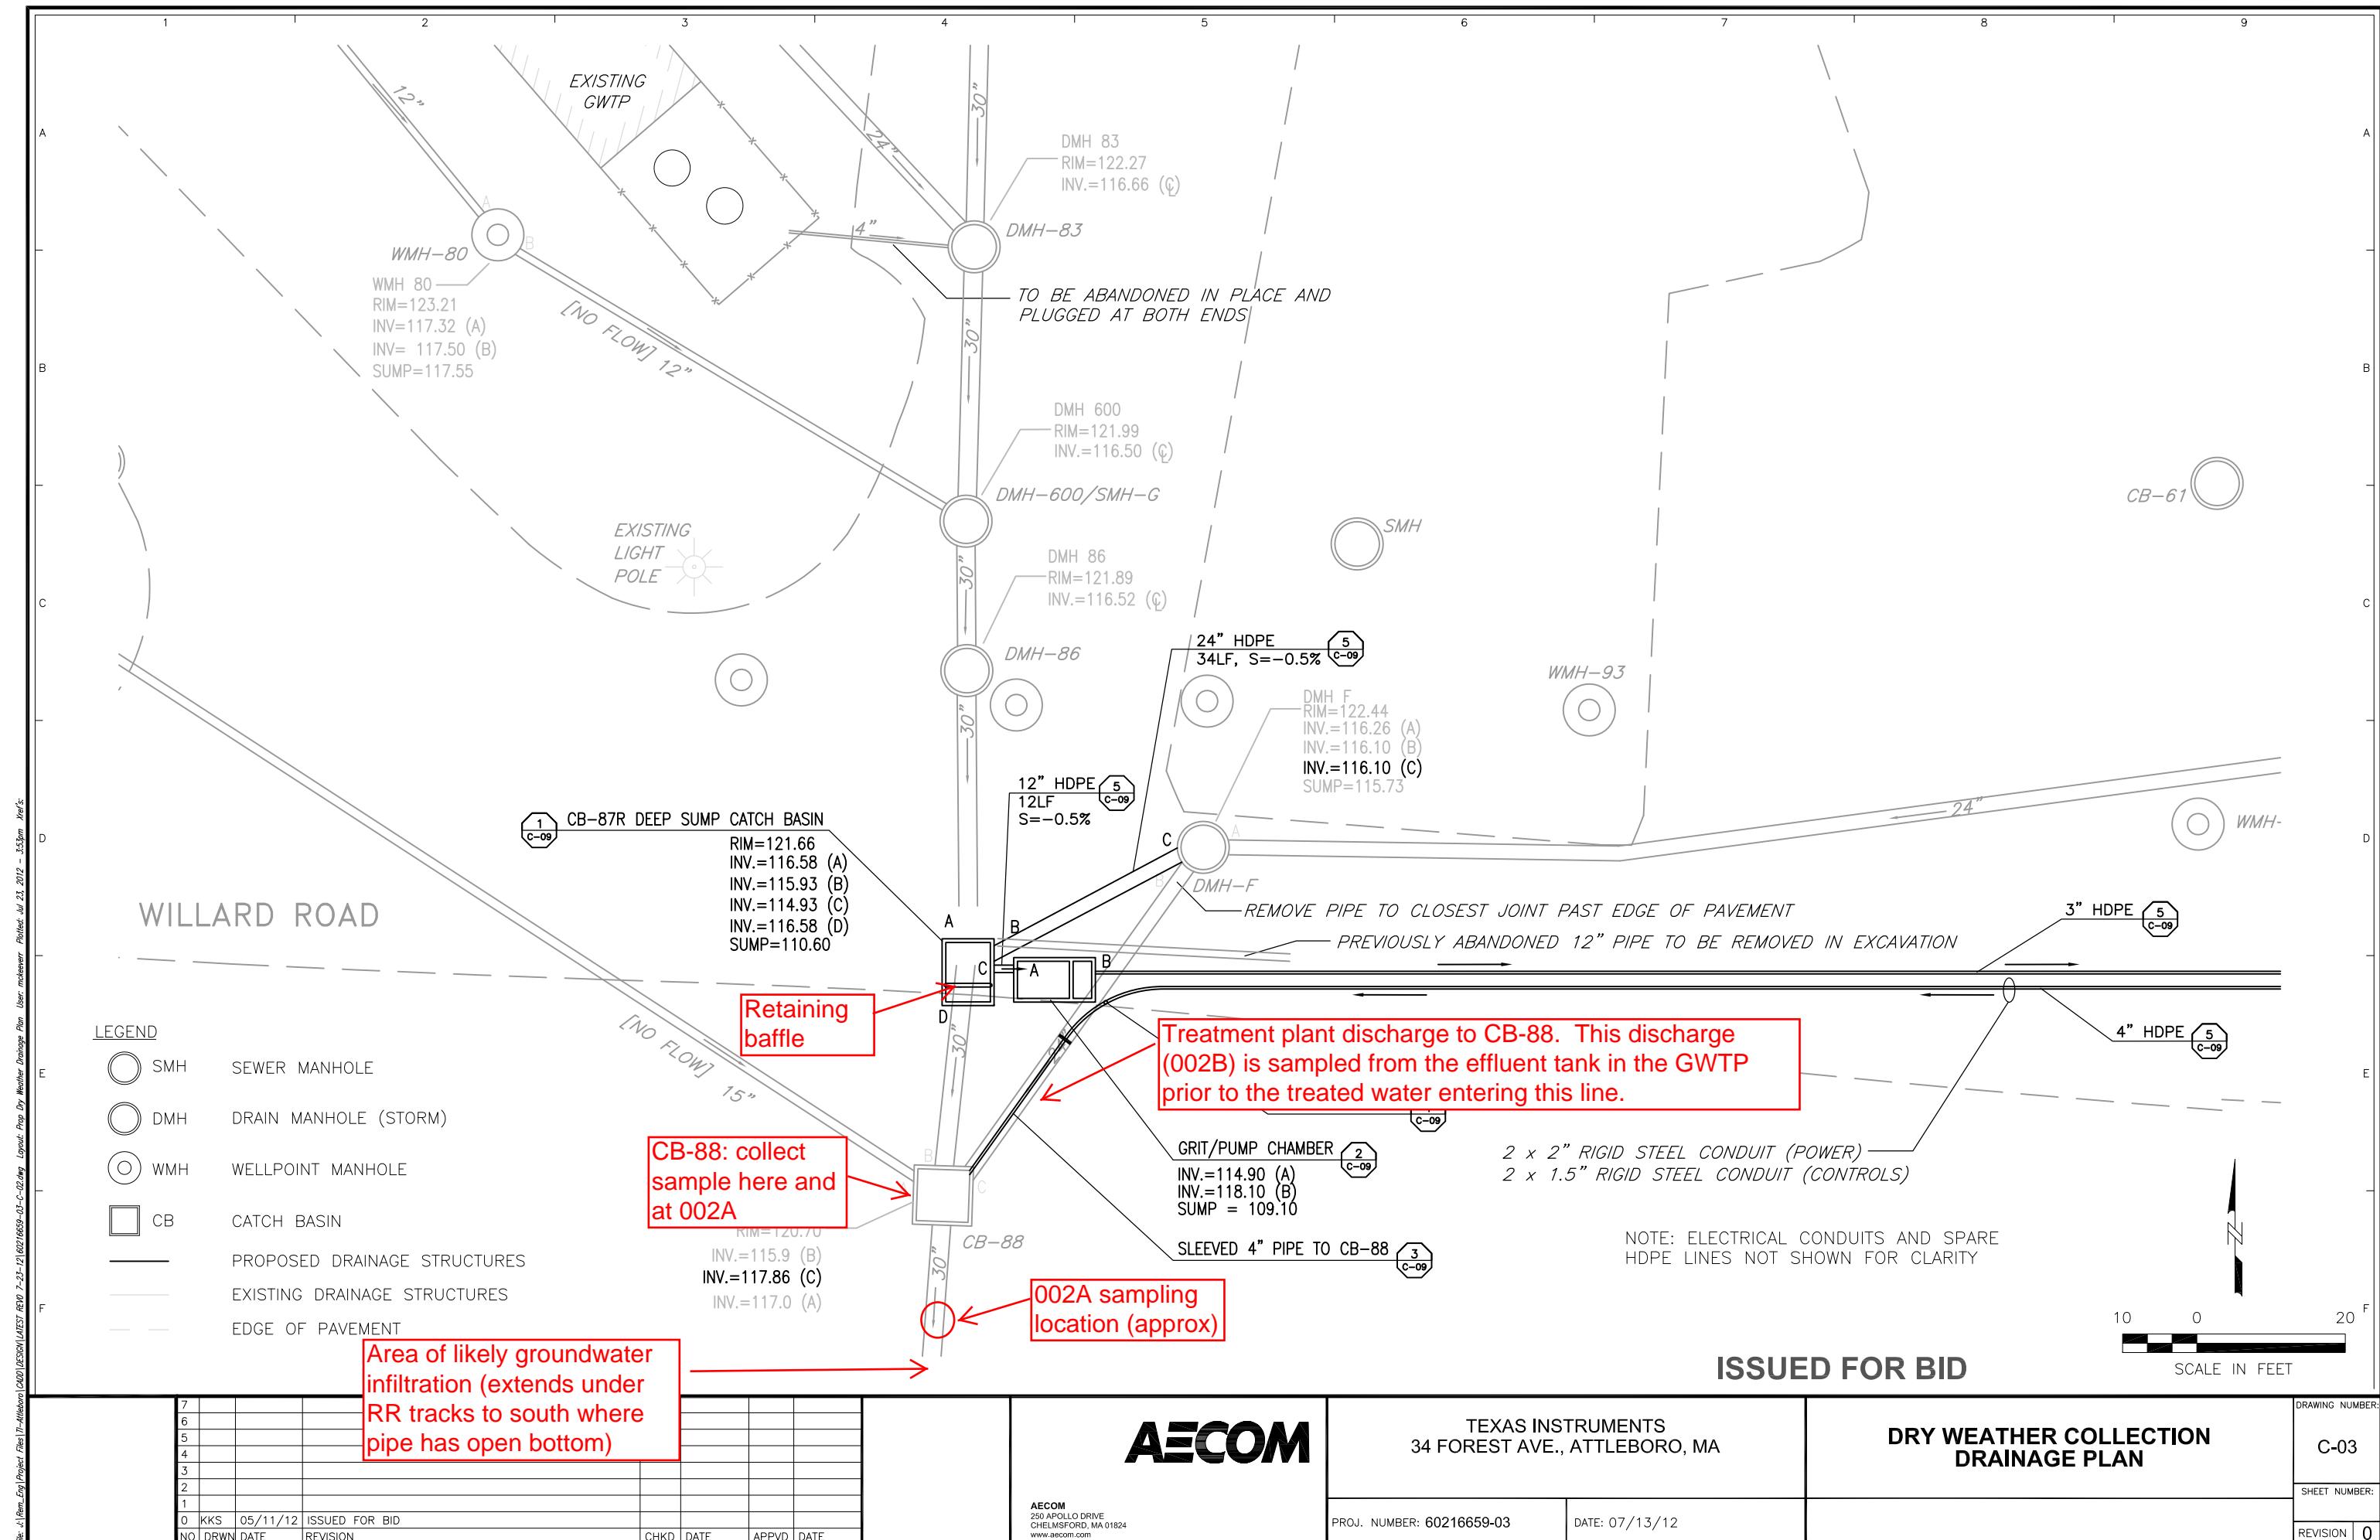
We believe the reason for this exceedance is that infiltration of groundwater containing TCE was occurring just downstream of the 002A sampling point. Just downstream of 002A, the discharge pipe is suspected to be open to groundwater as it passes under the railroad tracks. This was discovered with a visual inspection utilizing a water-proof mountable camera. We suspect that backflow from the railroad support structure (open bottom arch) through the 002A sample location could be occurring due to the lack of an enclosed outfall pipe. If this is occurring, the current 002A sample location would not solely represent treated water, during dry-weather conditions and assuming no breakthrough from CB-87R, as intended.

3. When the weather is dry, and the treatment plant effluent tank is not discharging, it has been observed that stagnant water is present in the vicinity of outfall 002A, suggesting that groundwater infiltration is occurring here.

1. Install a float switch on the downstream side of the retaining baffle in CB-87R. This activity began in March (float switch was purchased and is on site now) and arrangements are in progress to get it installed.
  - a. This will notify the operator if preventable bypass is occurring, allowing him to act quickly to correct the issue.
  - b. This will provide valuable information (frequency, seasonal variation, duration, etc.) for better understanding unavoidable bypasses (i.e. during a storm condition, or possibly when dry-weather flow is in excess of the current capacity of the collection and

2. Next month, collect a sample at CB-88 (just upstream of 002A, but just downstream of the pump chamber and where the treatment plant discharge enters the storm drain system) at the same day and approximate time that the 002A sample and other outfall samples are being collected. If no TCE is detected at CB-88, but is detected at 002A, it would demonstrate that the TCE at 002A is most likely from groundwater infiltrating to the storm drain between CB-88 and 002A. It had been intended to collect a sample from CB-88 in March also, but it was inadvertently not done.
